METAL / NONMETAL Serious Injury Accident

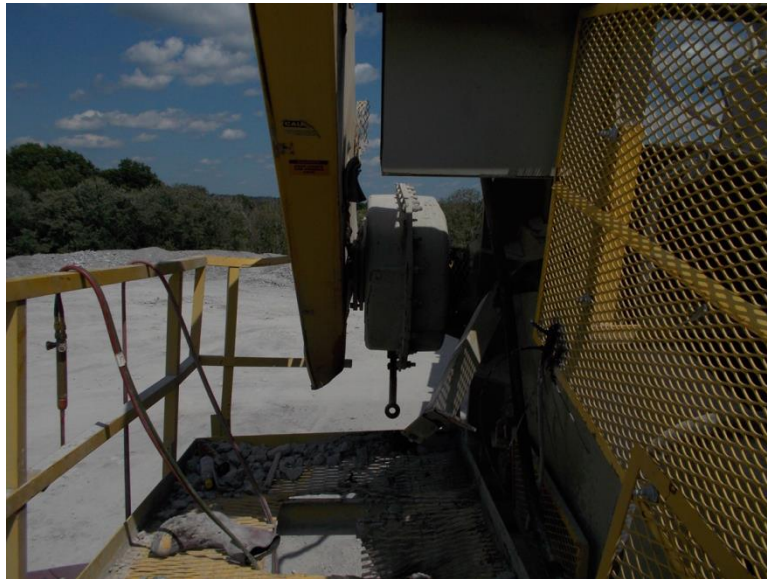
Underground Limestone Mine – Four miners were changing the head pulley drive belts and encountered a rusted gear that was preventing a turn buckle from turning. After unbolting the last bolt on the turn buckle the loaded conveyor belt started rolling downhill and the gear reducer started spinning on the head pulley shaft. One of the miners was severely injured when he was struck by the spinning reducer.

- Block conveyor belts from motion. Securing the belt from unintended motion can help assure your safety.
- Lock out conveyor power switches and tag them before you work on a conveyor.
- Perform thorough workplace examinations. Inspect the work areas for all potential hazards including places that persons may contact moving parts.
- Align conveyor belts from a safe location to prevent contact with moving parts.
